Acetabular Cup displacement as an unusual mode of failure

T.S.Rajagopal & M.M.Shah (✉)

Withybush General Hospital, Haverfordwest, SA61 2PZ, Wales, United Kingdom

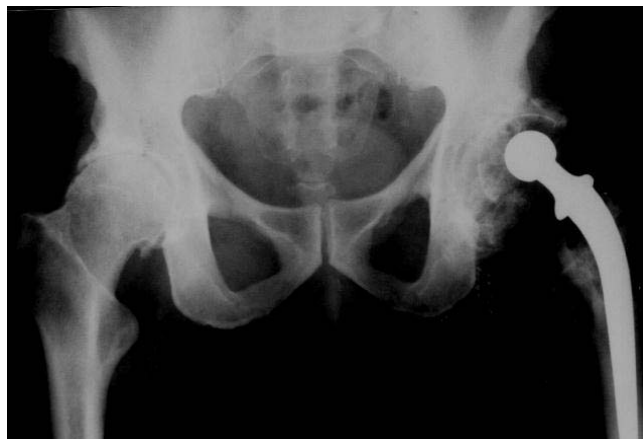
A 72-year-old man was seen for a disabling arthritis of his right hip. He had a Stanmore cemented Total hip replacement done 13 years ago on the left side, which was asymptomatic. Routine X-ray of the pelvis confirmed osteoarthritis of the right hip, and it also showed a loose and worn cup on the left side. (Fig.1).

Figure 1: Preoperative radiograph with loosening and wear of the left cup.

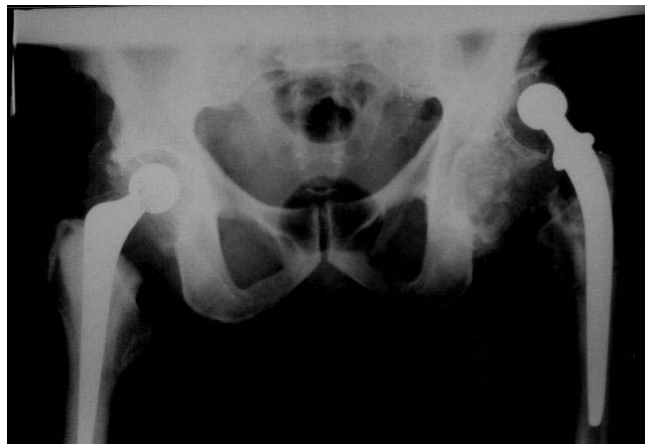
right total hip replacement was performed. The leg lengths appeared equal and at the end of the procedure whilst still on his side but on placing the patient on his back it was noted that the left leg was considerably shorter. X-rays were taken and it was revealed that the left acetabular component had migrated proximally up the lateral wall of the acetabulum (Fig. 2).

Figure 2: Postoperative radiograph showing displacement of the left cup.

tone helped to keep the acetabular cup in place. The decrease in muscle tone resulting from the spinal anaesthetic for contralateral hip replacement may have been an important causative factor in the acetabular cup migration in this patient.

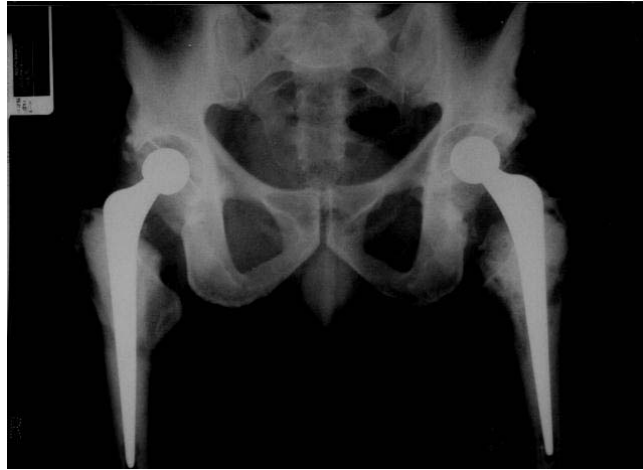
Figure 3: Radiograph after revision surgery of the left hip

The patient was mobilised with a shoe raise on this side and six weeks later had revision of the left total hip replacement. At operation the acetabular component was removed easily. The femoral component was still firmly fixed and the orientation was correct. Postoperatively, check radiographs showed prosthesis in situ (Fig. 3). The rehabilitation period was uneventful. At six month follow up patient was asymptomatic and doing well.
